**Flood Control Project Maintenance
Levee Inspections**

Maintenance Issue Types Only, Levee Inspection Report By Mile - Spring 2018

Merced Streams Group

Waterway	Bank	Unit Miles	Inspection Start/End	Inspector
Unit No. 01 Black Rascal Diversion	Right	1.61	04/06/2018 04/06/2018	Richard Willoughby

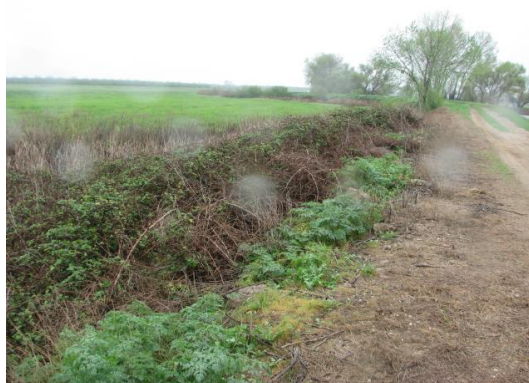
Photo 1 of 2 : SP_2018_NA0013_331_7_20180409_00010.jpg

LM Start	1.57	Rating **	U	Issue No.	7
LM End	1.61	Issue Type +	Ma	Location *	LS
Category	Earthen Levee			GPS Latitude/Longitude	
				Start	End
Item	Vegetation			37.336576 °	37.337098 °
				-120.396540 °	-120.396528 °
DWR ID	DWR_NA0013_01_s_2018_7				
Comment Code					
V2 : Remove the wild growth other than native grasses from the levee slopes.					
Inspector Comment					
Remove wildroses from landward slope.

Looking downstream at wildroses on landward slope. (Spring 2018)

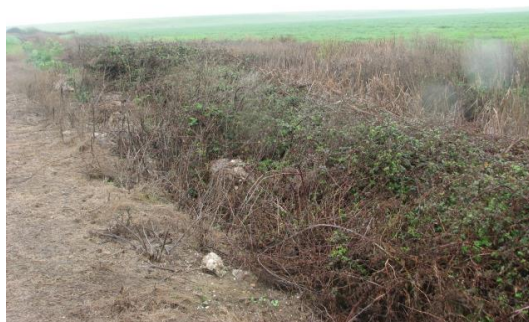
Photo 2 of 2 : SP_2018_NA0013_331_7_20180409_00011.jpg

LM Start	1.57	Rating **	U	Issue No.	7 (cont)
LM End	1.61	Issue Type +	Ma	Location *	LS

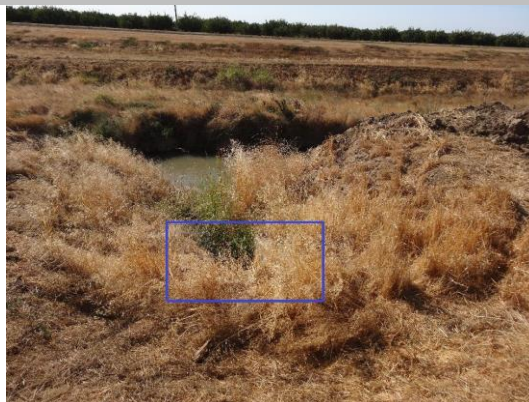
Photo 1 of 3 : UCIP_SP_2018_20984_35305.jpg

LM Start	1.30	Rating **	A/W	Issue No.	31
LM End	1.30	Issue Type +	Ma	Location *	
Category	Supplemental			GPS Latitude/Longitude	
				Start	End
Item	DWR UCIP LMA Responsibility			37.322499 °	37.322499 °
				-120.396045 °	-120.396045 °
DWR ID					
Comment Code					
Inspector Comment					
FS_ID:20984 DS_ID:23057 EP_NO: N/A Repair Type: No Action Needed Crossing Status: Found UCIP Comments: - working during field inspection. FIELD_STRUCT_DESC: 24-inch corrugated metal gravity drainage pipe through the levee, 10 feet below the crown. Concrete headwall, flap gate, and concrete grouted cobble spillway on the waterside (WS) toe. Concrete headwall on the landside (LS) toe. [Additional Reference(s): DWR Levee Log, 2005. USACE San Joaquin O&M Manual 607, June 1962, (HLM 1.32)]. FS Date: 9/17/2013

WS view: U type concrete headwall and channel on waterside.

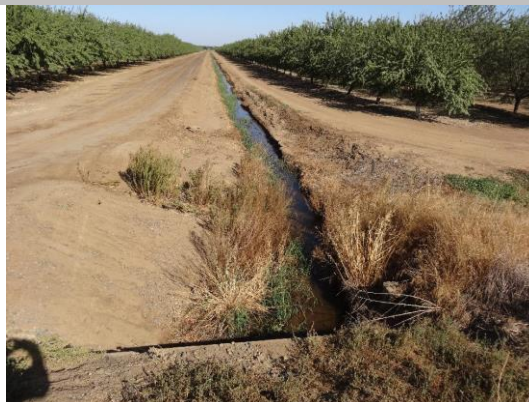
Photo 3 of 3 : UCIP_SP_2018_20984_35303.jpg

LS view: concrete headwall on levee toe and drainage ditch.

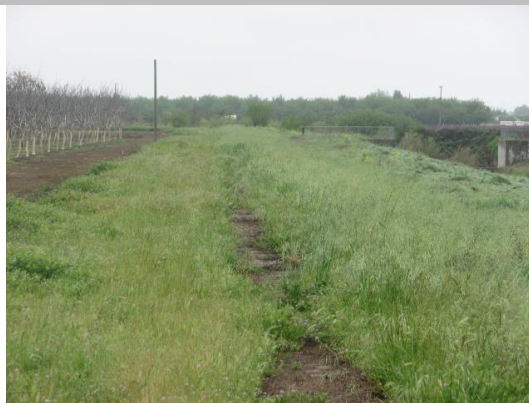
Photo 1 of 1 : SP_2018_NA0013_332_17_20180409_00038.jpg

LM Start	1.62	Rating **	U	Issue No.	17
LM End	1.85	Issue Type +	Ma	Location *	CR
Category	Earthen Levee			GPS Latitude/Longitude	
				Start	End
Item	Vegetation			37.317882 °	37.314609 °
				-120.395718 °	-120.395807 °
DWR ID	DWR_NA0013_02_s_2017_17				
Comment Code					
V9 : Keep the crown roadway free of vegetation.					
Inspector Comment					
Mowe to allow visibility and access.

Looking downstream at levee crown. (Spring 2018)

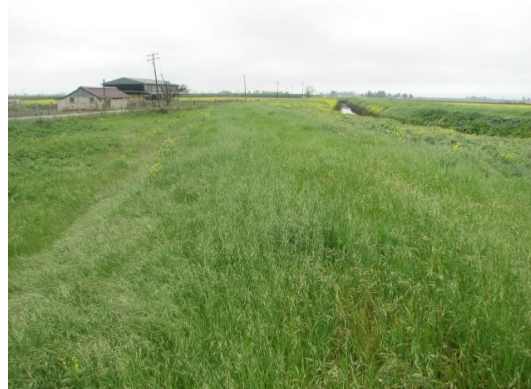
Photo 1 of 1 : SP_2018_NA0013_333_13_20180409_00027.jpg

LM Start	0.00	Rating **	U	Issue No.	13
LM End	0.43	Issue Type +	Ma	Location *	CR
Category	Earthen Levee			GPS Latitude/Longitude	
				Start	End
Item	Vegetation			37.257775 °	37.263795 °
				-120.288640 °	-120.288442 °
DWR ID	DWR_NA0013_03_s_2017_13				
Comment Code					
V2 : Remove the wild growth other than native grasses from the levee slopes.					
Inspector Comment					
Control wild growth on levee crown

Looking upstream at overgrown levee crown. (Spring 2018)

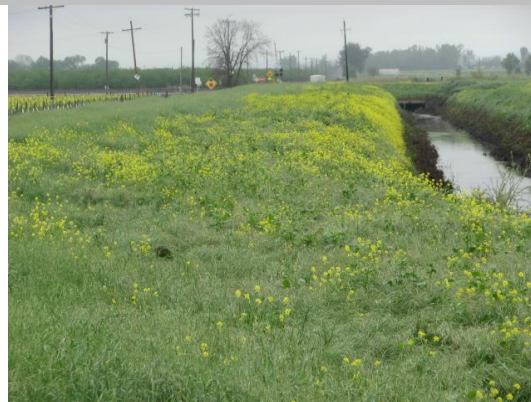
Photo 1 of 3 : SP_2018_NA0013_333_12_20180409_00028.jpg

LM Start	0.00	Rating **	U	Issue No.	12
LM End	0.43	Issue Type +	Ma	Location *	WS
Category	Earthen Levee			GPS Latitude/Longitude	
				Start	End
Item	Vegetation			37.257775 °	37.263796 °
				-120.288640 °	-120.288442 °
DWR ID	DWR_NA0013_03_s_2017_12				
Comment Code					
V2 : Remove the wild growth other than native grasses from the levee slopes.					
Inspector Comment					
Control wild growth on levee slope

Looking upstream at waterward slope. (Spring 2018)

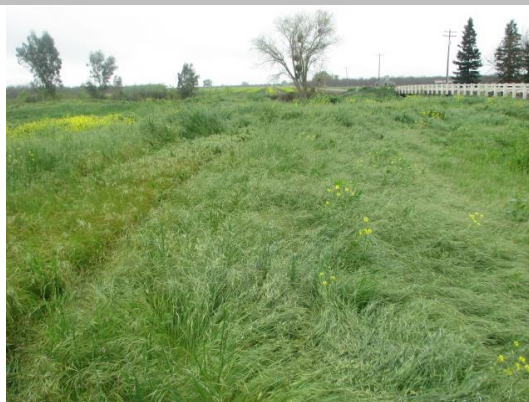
Photo 1 of 1 : SP_2018_NA0013_333_10_20180409_00029.jpg

LM Start	0.03	Rating **	U	Issue No.	10
LM End	0.43	Issue Type +	Ma	Location *	LS
Category	Earthen Levee			GPS Latitude/Longitude	
				Start	End
Item	Vegetation			37.258000 °	37.263796 °
				-120.288379 °	-120.288442 °
DWR ID	DWR_NA0013_03_s_2018_10				
Comment Code					
V2 : Remove the wild growth other than native grasses from the levee slopes.					
Inspector Comment

Looking downstream at landward slope. (Spring 2018)

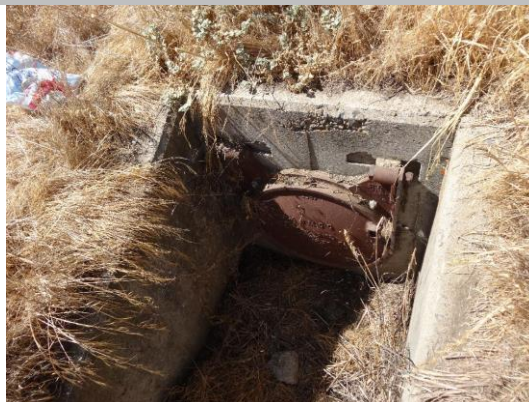
Photo 1 of 3 : UCIP_SP_2018_41815_35533.jpg

LM Start	0.19	Rating **	M	Issue No.	16	
LM End	0.19	Issue Type +	Ma	Location *		
Category	Supplemental			GPS Latitude/Longitude		
				Start	End	
Item	DWR UCIP LMA Responsibility			37.260355 °	37.260355 °	
				-120.288517 °	-120.288517 °	
DWR ID						
Comment Code						
Inspector Comment						
FS_ID:41815 DS_ID:23060 EP_NO: N/A Repair Type: Non-Urgent Crossing Status: Found UCIP Comments: - more than a half of inet pipe burried on LS. - needs vegetation cleaning on both sides.- inlet needs silt removed and cleaning. FIELD_STRUCT_DESC: 24-inch corrugated metal gravity drainage pipe through the levee, 6 feet below the crown. Concrete headwall, flap gate, and concrete grouted cobble spillway on the waterside (WS) toe. Concrete headwall on the landside (LS) toe. [Additional Reference(s): DWR Levee Log, 2005. USACE San Joaquin O&M Manual 607, June 1962, (HLM 0.18)]. FS Date: 9/17/2013

WS view: U typed concrete headwall, CM pipe, and flap gate.

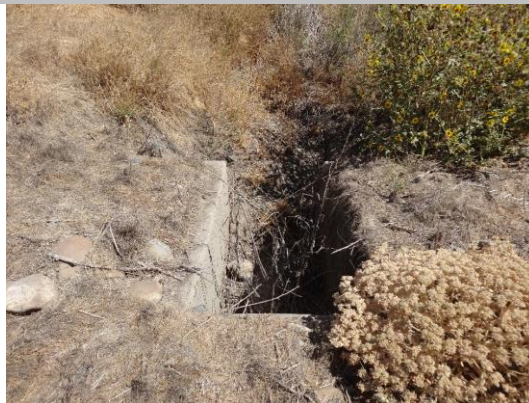
Photo 1 of 3 : UCIP_SP_2018_50144_35422.jpg

FS_ID:50144
DS_ID:23061
EP_NO: N/A
Repair Type: No Action Needed
Crossing Status: Found
UCIP Comments: 09/01/2016: Crossing has been downgraded from Urgent to No Action Needed. (K. Fazel - UCIP)09/01/2016: Not abandoned. LS and WS cleared. Gate swings free. Photos uploaded. (M. Walejko - NA0013)08/23/2016: Same as last inspection. (K. Fazel - UCIP)09/17/2013: Appears to be abandoned. Flapgate blocked by debris.- debris blocked inlet pipe on LS.- Needs to be cleared on both sides or it needs to be abandoned properly. (P. Amatya - UCIP)
FIELD_STRUCT_DESC: 24-inch corrugated metal gravity drainage pipe through the levee, 10 feet below the crown. Concrete headwall, flap gate, and concrete grouted cobble spillway on the waterside (WS) toe. Concrete headwall on the landside (LS) toe. [Additional Reference(s): DWR Levee Log, 2005. USACE San Joaquin O&M Manual 607, June 1962, (HLM 0.40)].
FS Date: 9/1/2016

WS view: U typed concrete headwall, cobble spillway, and channel on waterside.

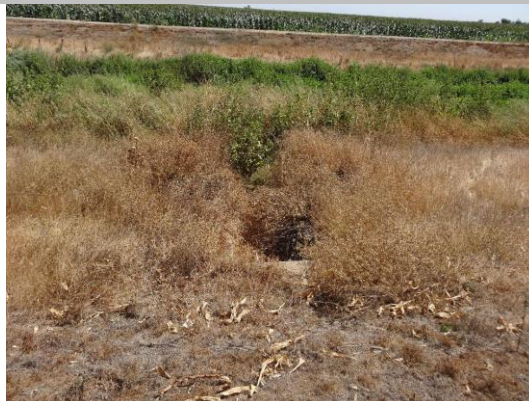
Photo 1 of 3 : UCIP_SP_2018_50151_35539.jpg

WS view: overview of spillway/outlet area on waterside.

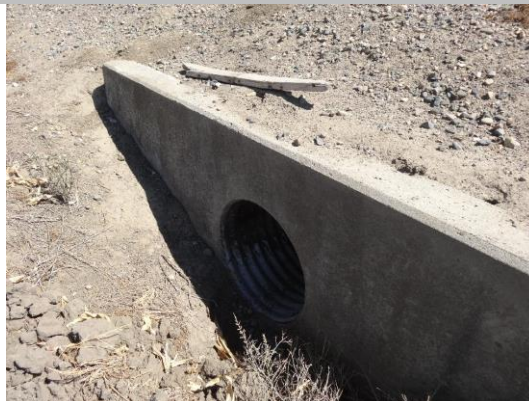
Photo 3 of 3 : UCIP_SP_2018_50151_35541.jpg

Comment Code					
Inspector Comment					
FS_ID:50151 DS_ID:23063 EP_NO: N/A Repair Type: No Action Needed Crossing Status: Found UCIP Comments: 09/2016: LS and WS ends have been cleared by NA0013 and crossing has been downgraded to No Action Needed. (K. Fazel - UCIP)09/2013: Needs vegetation clearing on WS. (P. Amatya - UCIP) FIELD_STRUCT_DESC: 24-inch corrugated metal gravity drainage pipe through the levee, 6.5 feet below the crown. Concrete headwall, flap gate, and concrete grouted cobble spillway on the waterside (WS) toe. Concrete headwall on the landside (LS) toe. [Additional Reference(s): DWR Levee Log, 2005. USACE San Joaquin O&M Manual 607, June 1962, (HLM 0.80), referenced as 10 feet below the crown]. FS Date: 9/7/2016

LS view: concrete headwall and CM pipe.

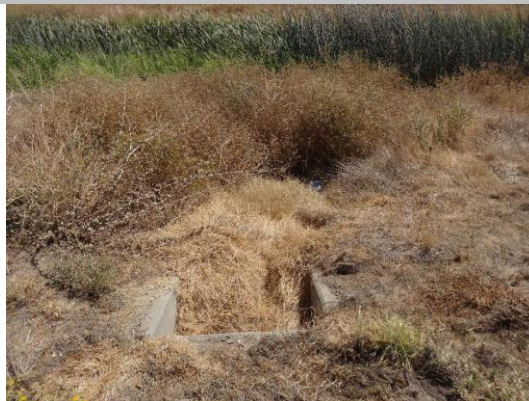
Photo 1 of 3 : UCIP_SP_2018_50152_35544.jpg

WS view: cobble spillway and channel on waterside.

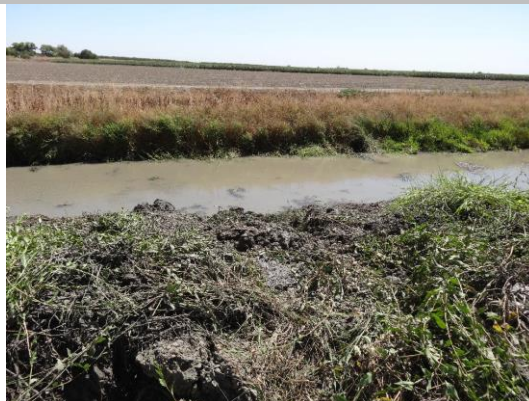
Photo 1 of 3 : UCIP_SP_2018_21063_35502.jpg

WS view: U typed concrete headwall, CM pipe, and flap gate buried under mud/debris.

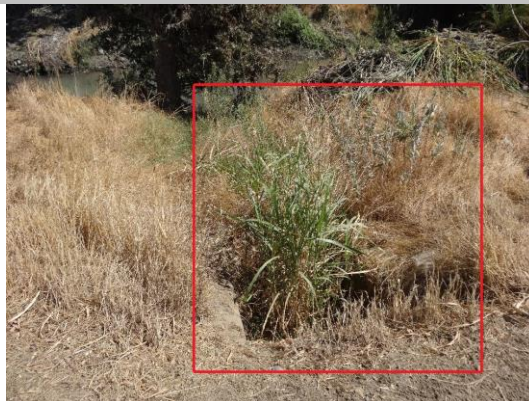
Photo 1 of 3 : UCIP_SP_2018_21064_35506.jpg

WS view: cobble spillway and channel on waterside. Dense vegetation on levee slope and spillway.

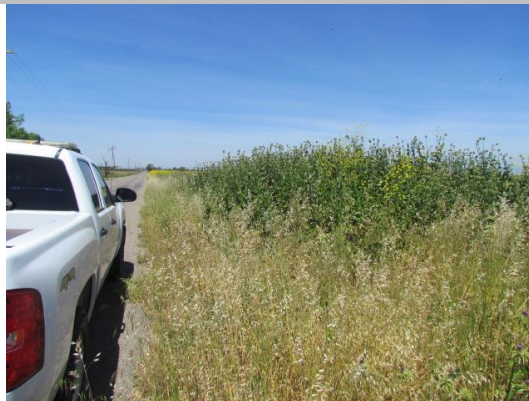
Photo 1 of 1 : SP_2018_NA0013_334_11_20180307_00002.jpg

LM Start	0.01	Rating **	U	Issue No.	11
LM End	1.41	Issue Type +	Ma	Location *	LS
Category	Earthen Levee			GPS Latitude/Longitude	
				Start	End
Item	Vegetation			37.273308 °	37.257383 °
				-120.277955 °	-120.288233 °
DWR ID	DWR_NA0013_04_s_2017_11				
Comment Code					
V2 : Remove the wild growth other than native grasses from the levee slopes.					
Inspector Comment					
Mow on crown and slopes.

Owens Creek Unit 4 looking upstream the unsatisfactory wild weed growth has completely block the view of the levee section.

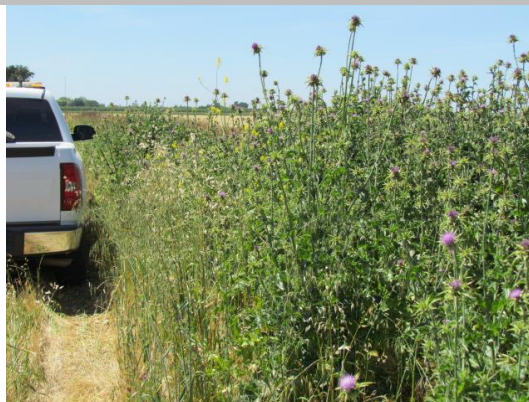
Photo 1 of 1 : SP_2018_NA0013_334_12_20180307_00004.jpg

LM Start	0.03	Rating **	U	Issue No.	12
LM End	1.41	Issue Type +	Ma	Location *	WS
Category	Earthen Levee			GPS Latitude/Longitude	
				Start	End
Item	Vegetation			37.273302 °	37.257383 °
				-120.278158 °	-120.288233 °
DWR ID	DWR_NA0013_04_s_2017_12				
Comment Code					
V2 : Remove the wild growth other than native grasses from the levee slopes.					
Inspector Comment					
Mow on crown and slopes.

Owens Creek Unit 4 looking at the waterside levee sloped downstream.

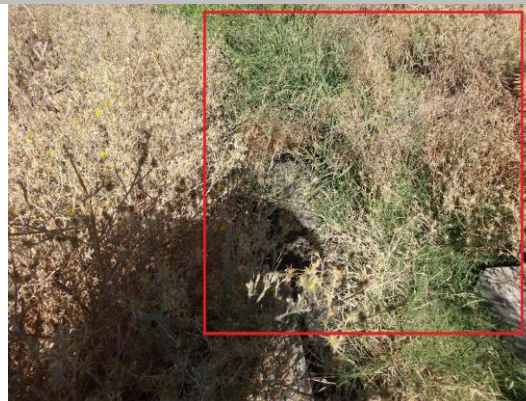
Photo 1 of 3 : UCIP_SP_2018_50148_35613.jpg

WS view: Dense vegetation on levee slope and spillway.

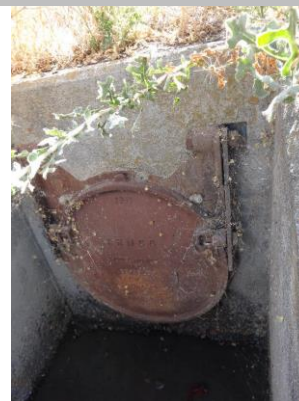
Photo 2 of 3 : UCIP_SP_2018_50148_35612.jpg

WS view: U typed concrete headwall, CM pipe, and flap gate.

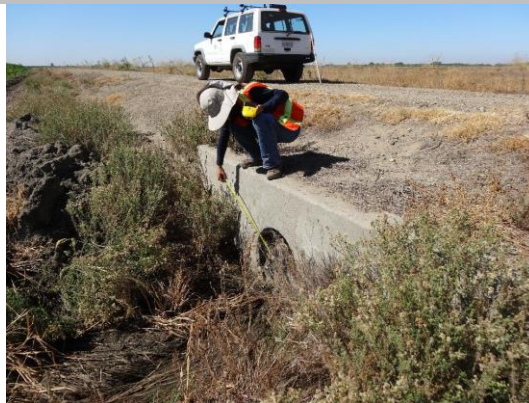
Photo 3 of 3 : UCIP_SP_2018_50148_35611.jpg

Comment Code						
Inspector Comment						
FS_ID:50148 DS_ID:23071 EP_NO: N/A Repair Type: No Action Needed Crossing Status: Found UCIP Comments: 09/29/2016: WS headwall, flap gate and spillway have been cleared of vegetation by Mike Walejko of NA0013. Crossing has been downgraded from Non-Urgent to No Action Needed. (K. Fazel - UCIP)09/2013:- vegetations clearing on spillway area. (P. Amatya - UCIP) FIELD_STRUCT_DESC: 24-inch corrugated metal gravity drainage pipe through the levee, 5 feet below the crown. Concrete headwall, flap gate, and concrete grouted cobble spillway on the waterside (WS) toe. Concrete headwall on the landside (LS) toe. [Additional Reference(s): DWR Levee Log, 2005. USACE San Joaquin O&M Manual 607, June 1962, (HLM 0.45)]. FS Date: 9/7/2016

LS view: concrete headwall and CM pipe.

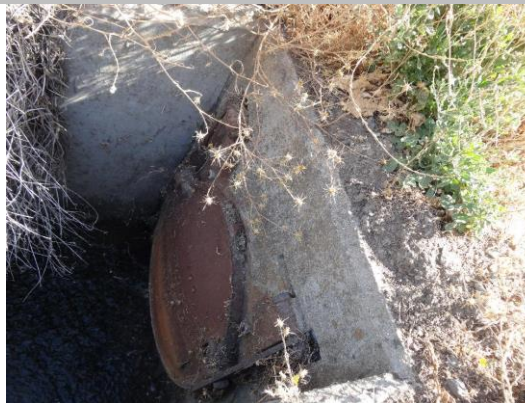
Photo 2 of 3 : UCIP_SP_2018_21126_35651.jpg

WS view: U typed concrete headwall, CM pipe, and flap gate. Vegetation needs to be cleared on spillway.

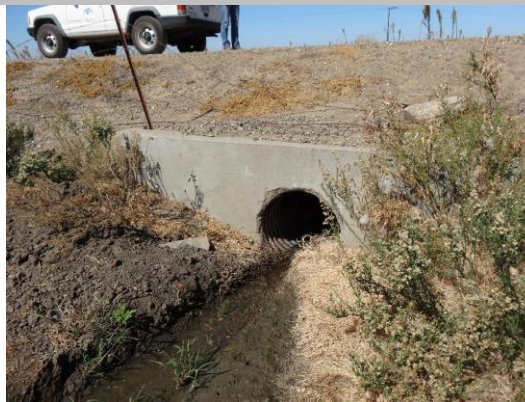
Photo 3 of 3 : UCIP_SP_2018_21126_35654.jpg

LS view: concrete headwall and CM pipe. Drain pipe was working during field survey.

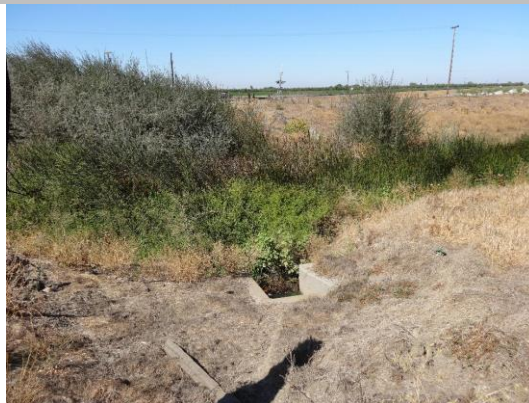
Photo 1 of 3 : UCIP_SP_2018_21127_35657.jpg

WS view: U typed concrete headwall and channel on waterside.

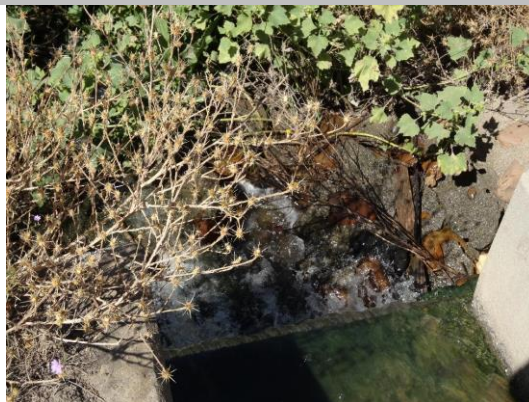
Photo 2 of 3 : UCIP_SP_2018_21127_35656.jpg

WS view: concrete headwall and concrete spillway on waterside.

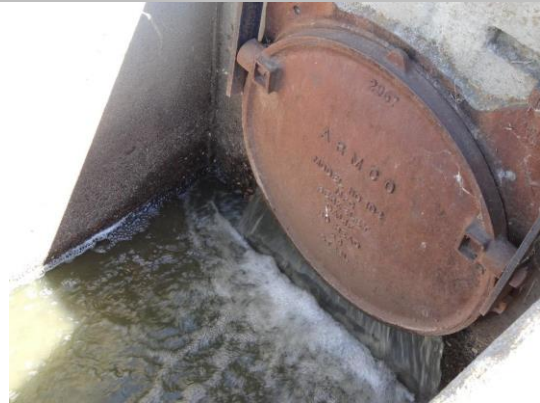
Photo 3 of 3 : UCIP_SP_2018_21127_35655.jpg

LM Start	1.01	Rating **	A/W	Issue No.	21 (cont)
LM End	1.01	Issue Type +	Ma	Location *	
Category	Supplemental			GPS Latitude/Longitude	
				Start	End
Item	DWR UCIP LMA Responsibility			37.263139 °	37.263139 °
				-120.287799 °	-120.287799 °
DWR ID					
Comment Code					
Inspector Comment					
FS_ID:21127 DS_ID:23074 EP_NO: N/A Repair Type: No Action Needed Crossing Status: Found UCIP Comments: - concrete spillway on waterside.- drainage was working during field survey. FIELD_STRUCT_DESC: 24-inch corrugated metal gravity drainage pipe through the levee, 8 feet below the crown. Concrete headwall, flap gate, and concrete grouted cobble spillway on the waterside (WS) toe. Concrete headwall on the landside (LS) toe. [Additional Reference(s): DWR Levee Log, 2005. USACE San Joaquin O&M Manual 607, June 1962, (HLM 1.02)]. FS Date: 9/17/2013

WS view: U typed concrete headwall, CM pipe, and flap gate. Drainage was working during survey.
